COMMONWEALTH OF PENNSYLVANIA
Department of Transportation

RESEARCH PROJECT NO. 96-054A
GEOSYNTHETIC CLAY LINER

FINAL REPORT
JULY 1998

SR 3040-001, Berks County

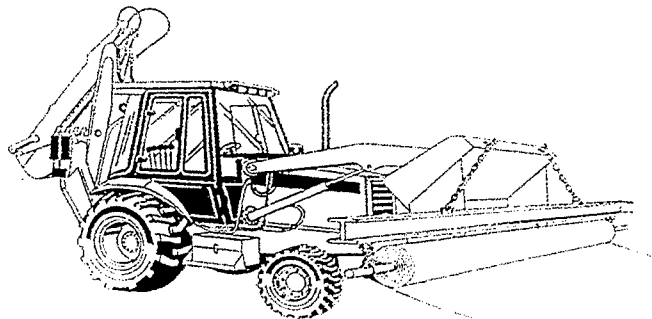
Figure 2 - Backhoe with Spreader and Core Bar Attachment

The GCL was installed by grading the swale areas using the grader and Gradall (See Photo 1 through 3). Because of tight traffic conditions, a front end loader was used to haul excess fill material away from the adjacent traffic lanes. Once grade was achieved, the Bentomat® ST liner was rolled out on the grade using a backhoe with spreader and core bar attachment. Refer to Figure 2 below.

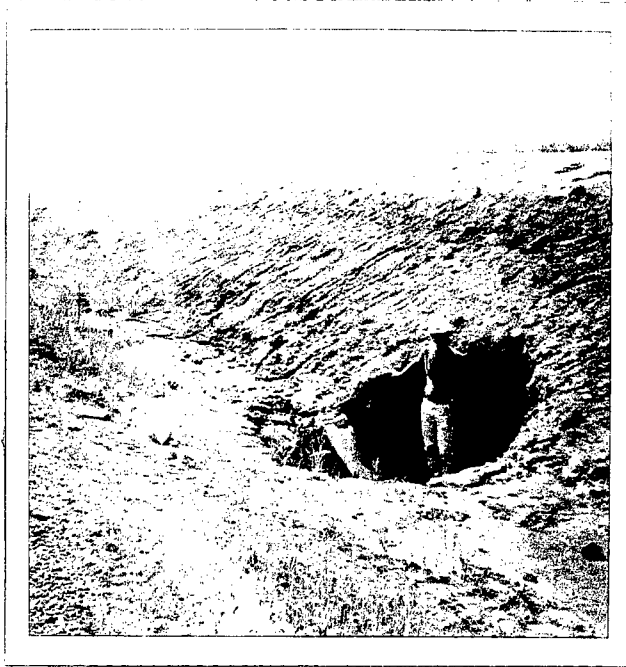
This research project was initiated due to the formation of a recurring sink hole on this project site. The sink hole first appeared in the swale adjacent to the location at which a cross pipe empties into the swale at STA 139+50 Rt. (See photo 12). This condition is usually repaired by excavating down into the sinkhole to bedrock, to locate the eye or throat of the sinkhole. Then the hole is filled with a few feet of concrete. After the concrete sets, the rest of the hole is lined with Class 2 Type A woven geotextile and filled with an impervious, soil-like clay. Then the site is covered with topsoil, dressed up, and seeded. This conventional method of sinkhole repair (outlined in Appendix C) could not be used due to the shallow depth to the bedrock. The Project Engineer could only fill the sinkhole with concrete, cover the concrete with topsoil, and seed the area. A few weeks after this repair was made, the sinkhole reappeared on either side of the repair area (See photo 13). These two small sinkholes were also repaired with concrete, and the GCL was installed. The Geosynthetic Clay Liner material seems to have mitigated the recurrence of any further sinkhole activity within the project area. For this reason Bentomat® ST, supplied by Colloid Environmental Technologies Company, is recommended for approval for sinkhole mitigation on all future Department projects where this material is warranted.

Photo 1, Initial sinkhole that appeared, 1996.

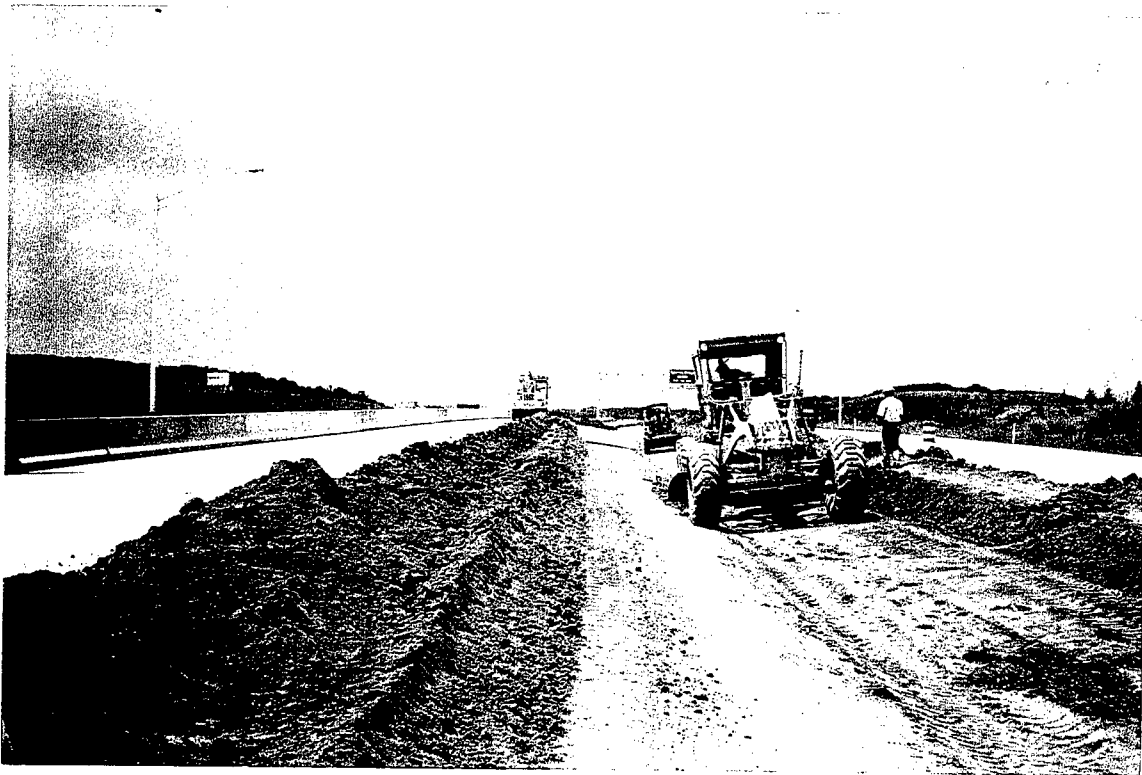
Photo 2, A grader was used to remove the topsoil in the swale.

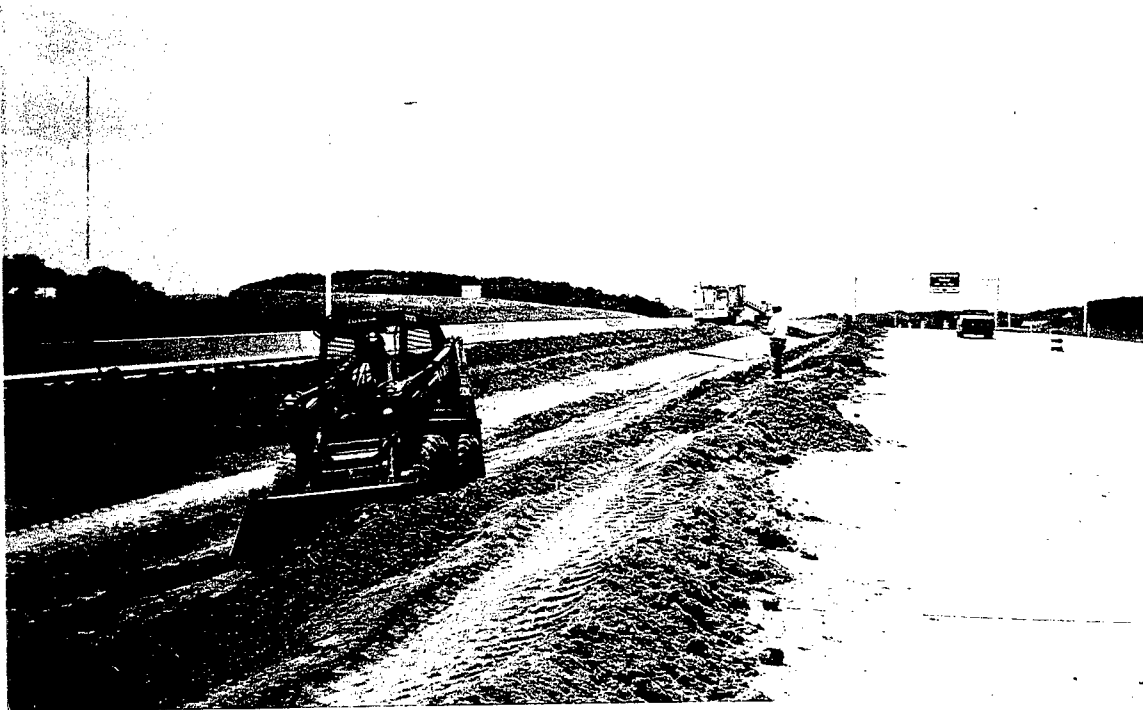
Photo 3, A skid loader was used to remove excess windrows.

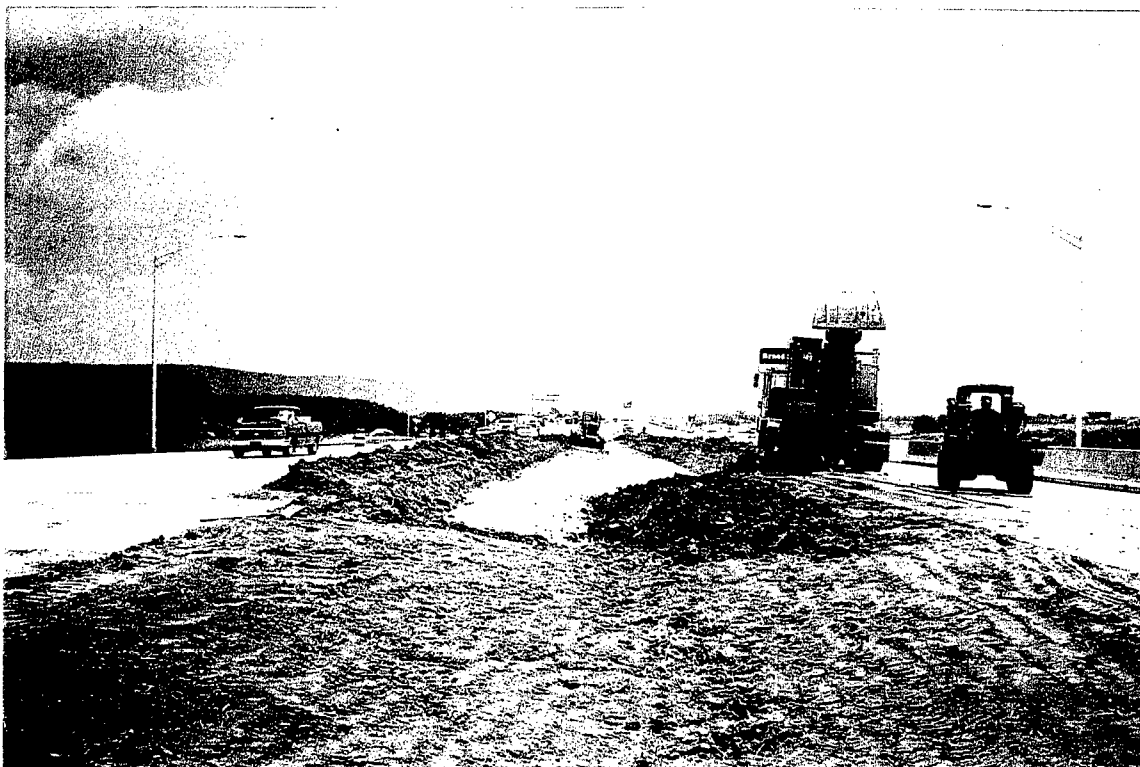
Photo 4, Shows the Gradall preparing to backfill the GCL material.

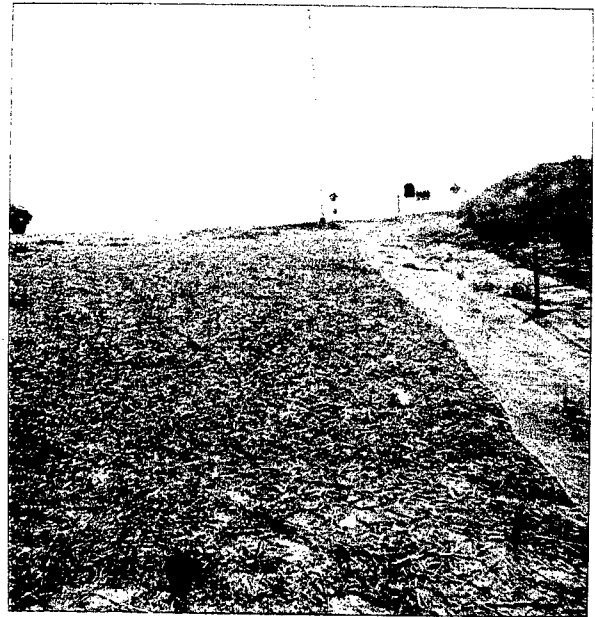
Photo 6, Final Inspection
STA 137+00 to 141+92 Rt.
Swale

To date, no sink hole activity at the locations where the GCL was installed has been observed. Some scouring and settlement problems have occurred between STA 137+00 and STA 142+00 in the right swale area due to high flow rates (See photos 14 & 16). This area will need to be redressed. Although there is some established growth in this area, it is recommended in the future, under similar circumstances, that a rock-lined swale be placed over the GCL, in lieu of topsoil and seed.

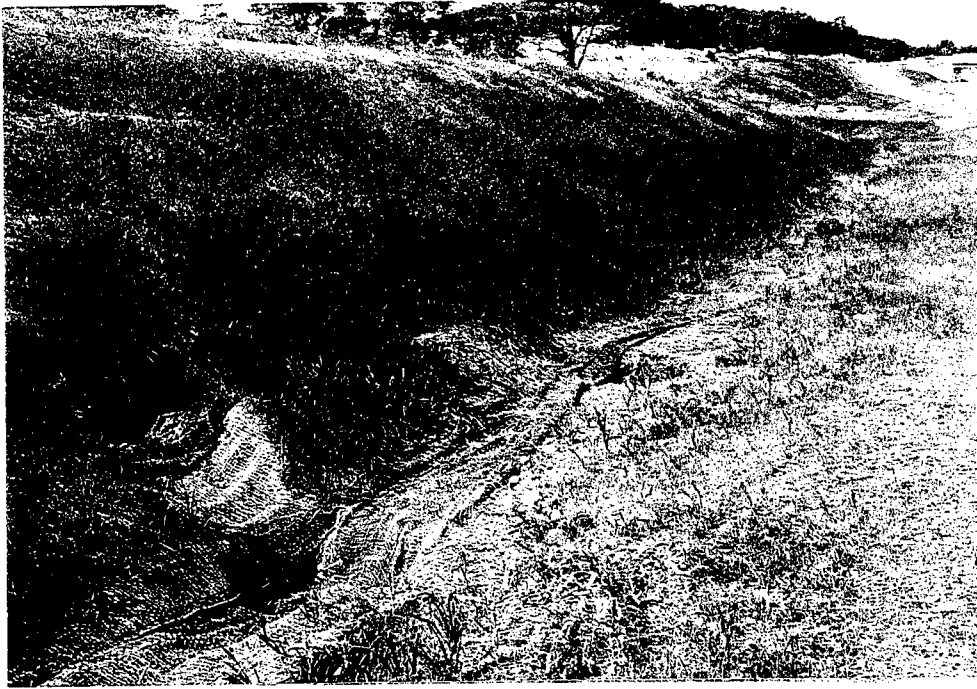
Photo 13, After the sinkhole was repaired, two sinkholes formed on either side of the repair at STA 139+80 Rt.

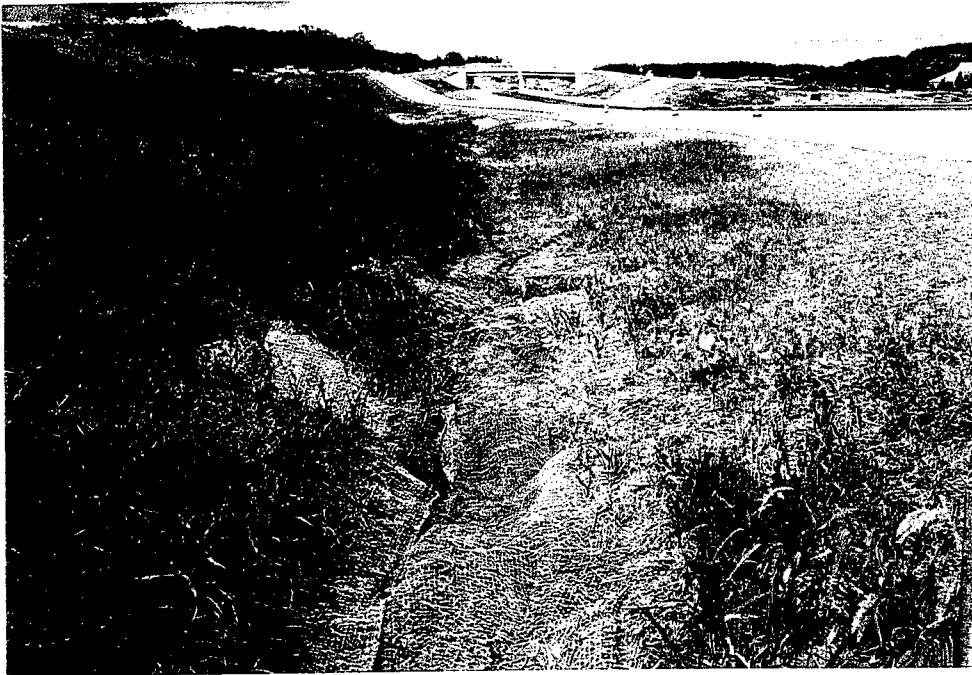
Photo 14, Shows the sinkholes that developed after the repair.

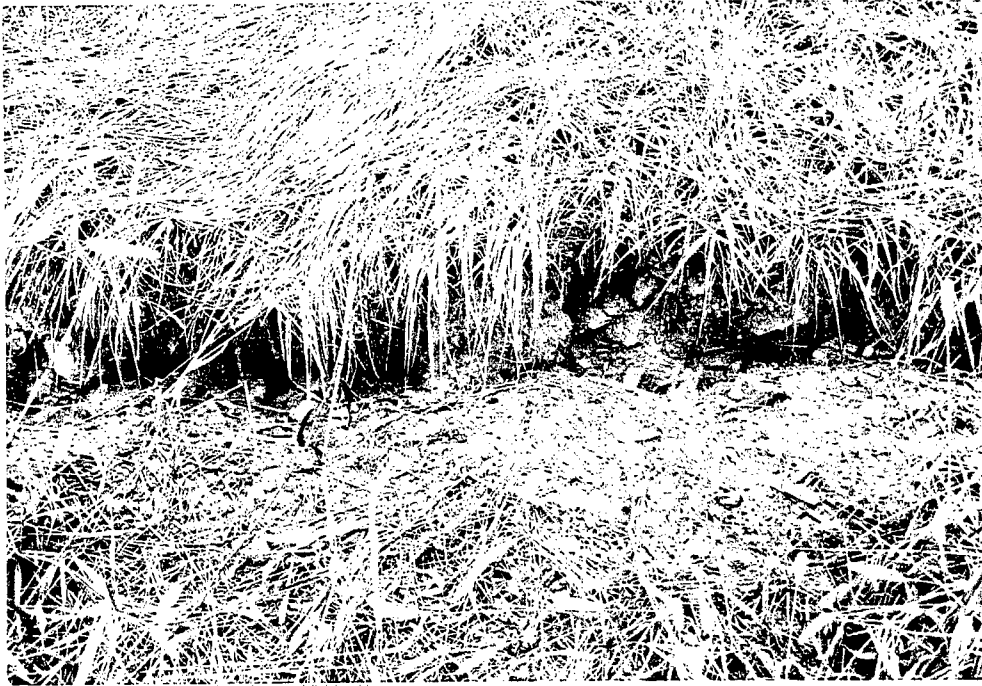
Photo 15, Shows the sloughage adjacent to the swale, where the GCL was placed.

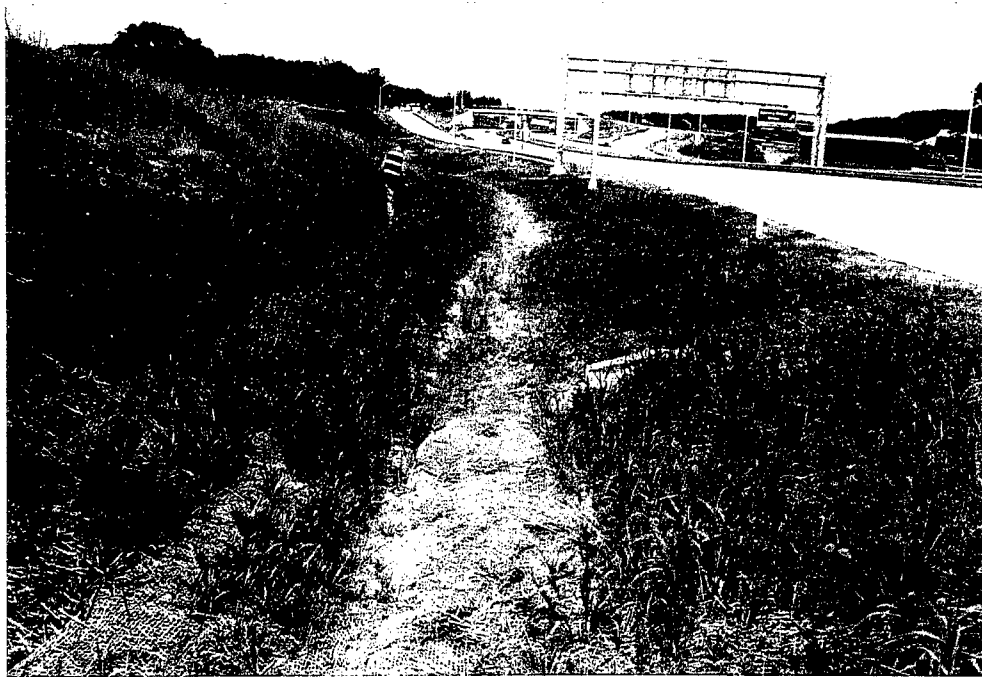
Another observation that also should also be addressed is that during the summer of 1997, there was a drought in Pennsylvania. The drought lasted several weeks. During this long period without rain, the grass within the project area dried out and became brown, except the area where the GCL was placed in the swales. The material only had six inches of cover, yet managed to maintain enough moisture to allow new grass to survive and flourish (See photo). This has little bearing on this research project but may be of interest to Departments of Transportation in the arid Southwest United States, where maintaining a grass-lined swale without irrigation may be important.

Photo 16, Shows the GCL maintaining vegetation in the swale during a drought.
